A Suitable Landscape Design for Areas Affected by Gully Erosion in Jos, Plateau State, Nigeria

Abstract:

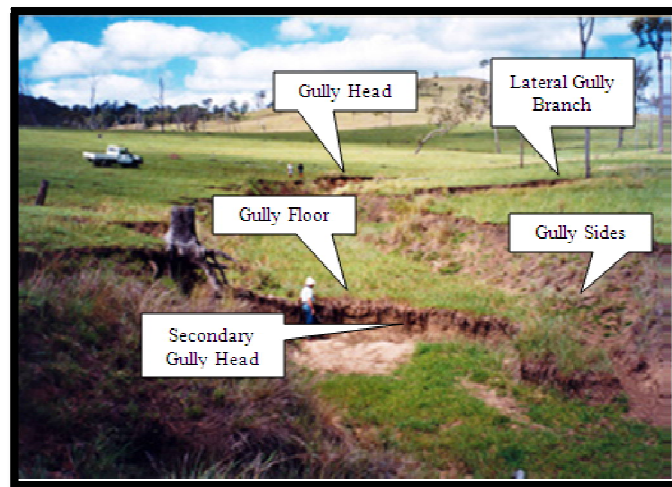
The various components of a gully are illustrated in Figure 1. They include the head, sides and the bed or floor of a gully. As a gully lengthens, it develops lateral branches. There may be several gully heads advancing up a gully at any one time in what can be called a 'steps and stairs' pattern.

Figure 1: The Components of a Gully
 Source: Adapted from Soil Conservation Guidelines for Queensland, 2015

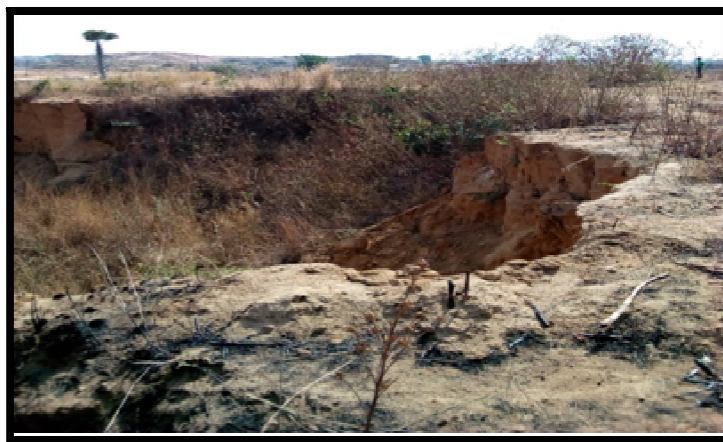
Figure 2: Expansion of a Gully at Site
 Source: Researchers' Field Work, 2018

The following processes causes expansion of gullies these are raindrop impact, tunneling in dispersive soil, spalling, slaking , trickle flows, gully head advancement, basal sappingetc.

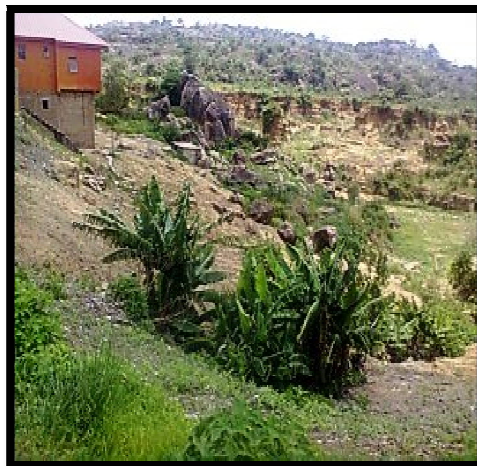
The topography of the site is a complex form that was forged gradually by erosion on the area which has been battered by mining activities, so a sketch was made of the contour on the survey map from data (elevation) take by the use of a hand held Geographical Positioning System device (GPS). The altitude of major land forms were taken and supplemented with computer generated coordinates and altitude from satellite imagery (Google earth 2016) for a wider coverage and precise space analysis in the course of the design process. Figure 7 and v shows the rock formation on and off site depicting the topography of the area

Figure 7: Topographic View from Off-Site
Source: Researchers' Field Work, 2018

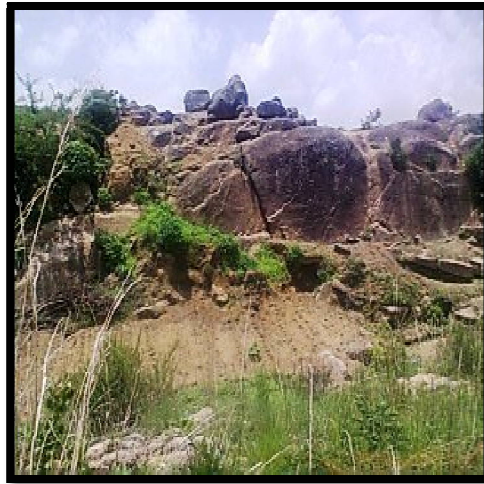
*Figure 8: Topographic View from on Site
Source: Researchers' Field Work, 2018*

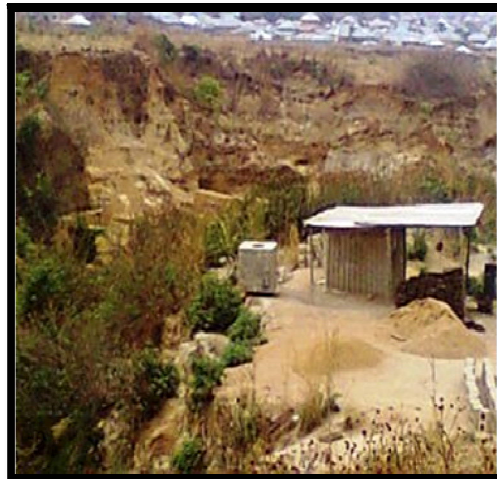
Figure 9 to Figure 11 shows the reality of erosion menace and mining activities on the Jos Plateau which has led to less productive and continuous deteriorating land mass within the study area.

*Figure 9: A Deep Gully Located on Site
Source: Researchers' Field Work, 2018*

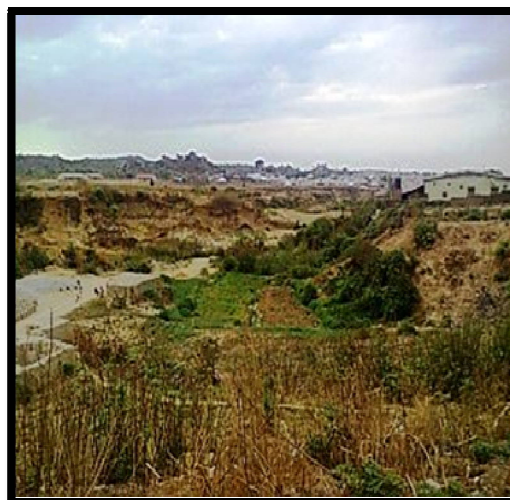
*Figure 10: The reality of Erosion Menace on site
Source: Researchers' Field Work, 2018*

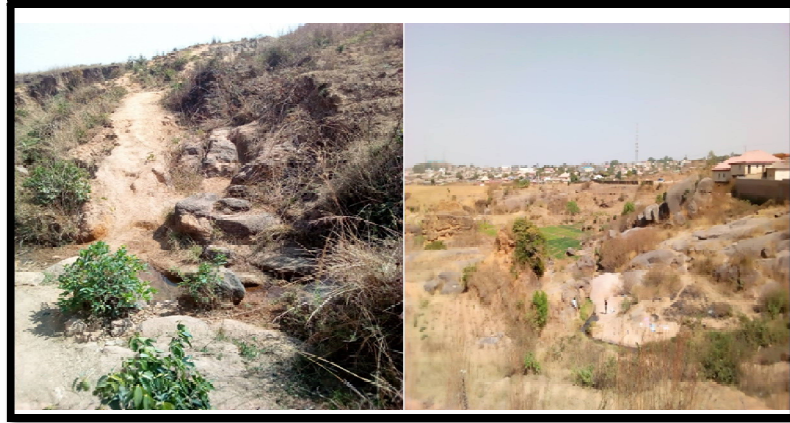
*Figure 11: Gully Eroded and Deteriorating Land Mass on Site
Source: Researchers' Field Work, 2018*

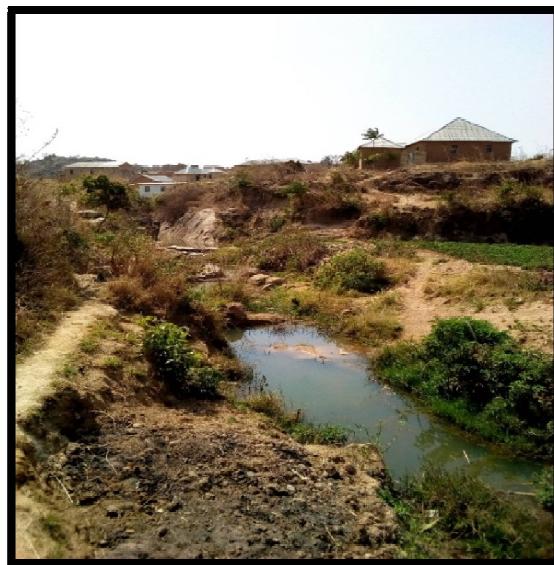
The site is undulating and has its drainage in different directions according to the land form (topography), with the greater part of the runoff flowing to the lowest part of the site; most of this runoff is channeled by existing water path on the site. Photographic images can be seen in Figure12 and Figure13

*Figure12: Minor Water Way on Site
Source: Researchers' Field Work, 2018*

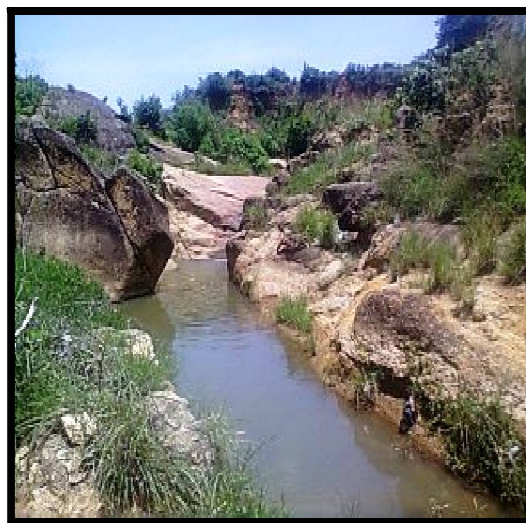
*Figure 13: Drainage Channel within the Gully Eroded Site
Source: Researchers' Field Work, 2018*

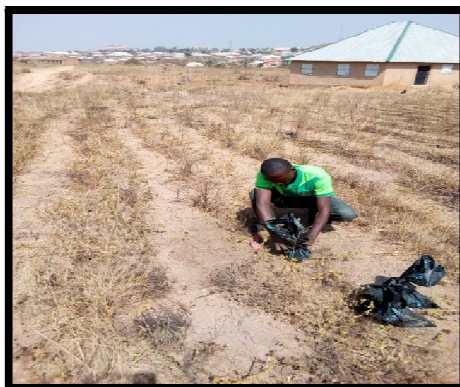
Information obtained through the 'Feel Method Test' for the soil on site to be predominantly laterite, clay and clay-loam, distributed throughout the site with no defined pattern. Soil erosion is a major environmental problem on the site. Tin mining, in its heyday, rendered some localities around the site more susceptible to soil erosion. Today, however, the soil erosion menace is being accentuated largely by lack of maintenance of green surfaces which has resulted in gullying along the numerous paths which criss-cross the Tudun-wada area surface as revealed in Figure14 and Figure15.

Figure 14: Soil on Site
Source: Researchers' Field Work, 2018

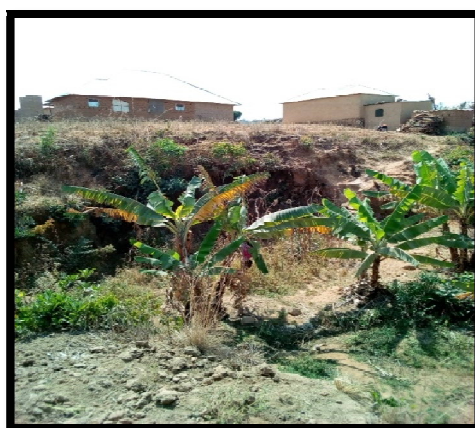
Figure 15: Soil Type in the Gully Eroded Site
Source: Researchers' Field Work, 2018

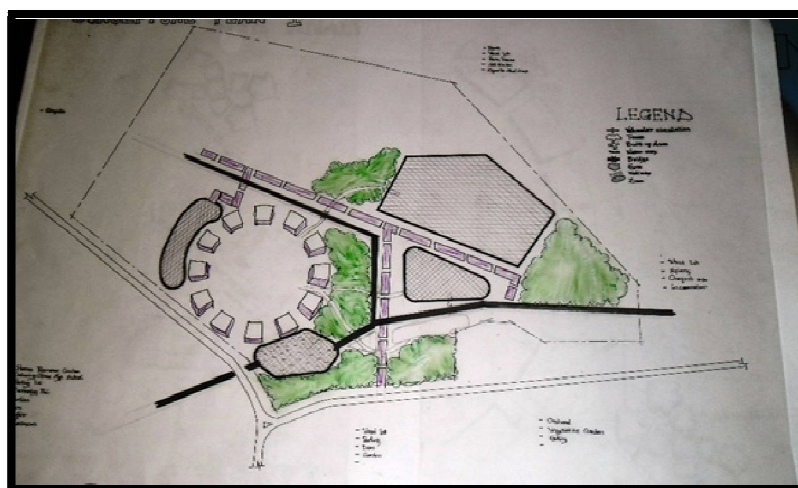
Figure 19: Preferred Conceptual Plan
 Source: Researchers' Design Drawing, 2018

The researchers proposed the development of three conceptual plans (with conceived spaces for the landscaping) from which the most preferred was selected using the "Grade Score Table" in Table 2. Conceptual plan two was the most preferred based on aesthetics, circulation, economy, and functionality, and was developed fully by imputing required details and scale to bring it through an evolutionary process from concept to Landscape Master Plan to resuscitate the degraded landscape to a sustainable design as seen in Figure 6.

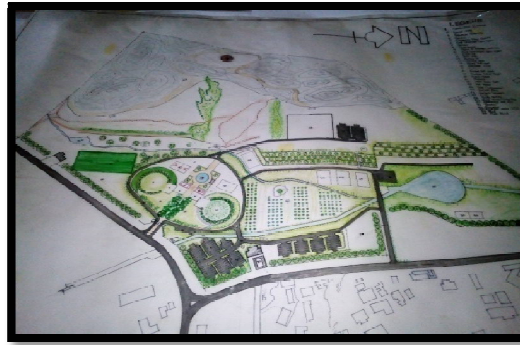
The master shows a graphic presentation of the finished design, with a degree of detail as presentable on a scale of 1:1000. The master plan shows among others, the visual spatial relationship between spaces and a various facilities and network of pedestrian and vehicular circulation routs. The plants as proposed in the planting scheme are represented especially by the various plant canopies, while drainage systems are also evident. The master plan shows the three main parts /zones of the site clearly with different mode of demarcations and linkages thereby revealing the interrelated concept of the proposed landscape design to uphold sustainability. Figure 7-Figure9 highlights the developed landscape master plan.

Figure 20: Landscape Master Plan
Source: Researchers' Design Drawing, 2018

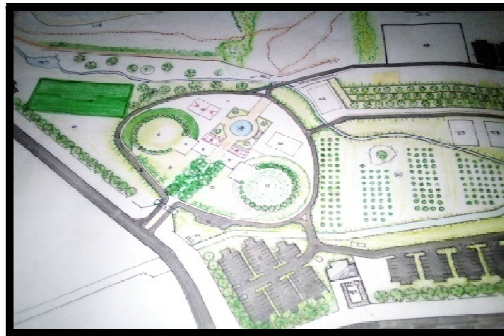
Figure 21: A Detailed View of the Landscape Plan
Source: Researchers' Design Drawing, 2018

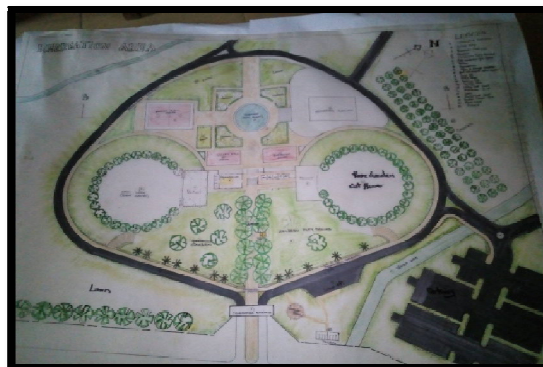
Figure 22: An Enlarged View of the Recreation Area
Source: Researchers' Design Drawing, 2018
